# Town Meeting

March 11, 2016

## Safety Update

# Recent Events at NSLS-II

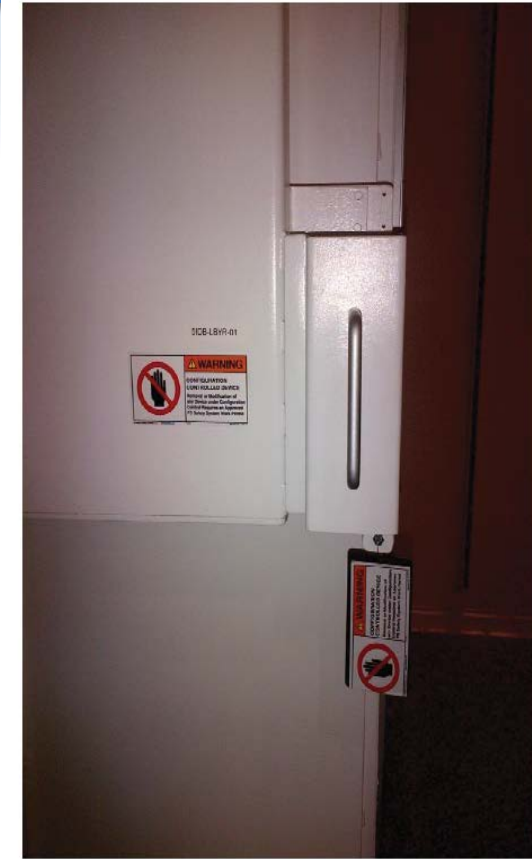
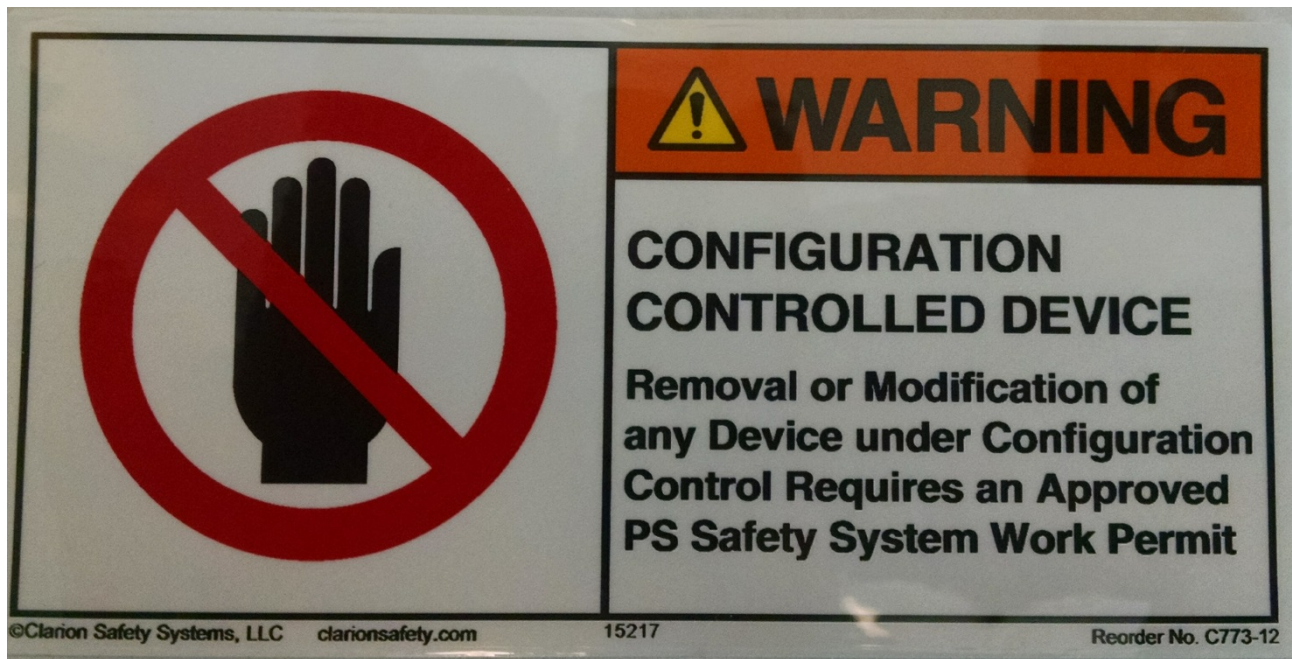
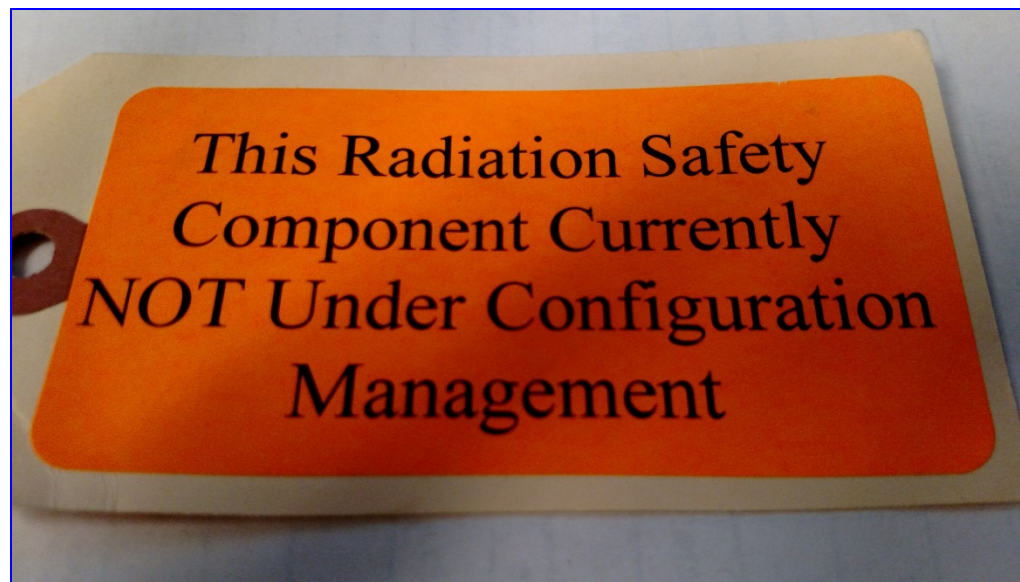
# Unsecured Cable Labyrinth

**Description:** While performing radiation surveys on Friday 1/29 for the 5-ID beamline, the radiation control technician noticed that a cable labyrinth wasn't secured. She brought this to the attention of ESH staff on the following Monday. ESH staff confirmed the labyrinth was not in its approved configuration. A violation of the NSLS-II Accelerator Safety Envelope was declared and the beamline disabled. A temporary work suspension was issued by the NSLS-II Director so the event could be discussed with all staff. The labyrinth had been taken out of service to permit installation of smoke detector cables. Installation of the smoke detector cables was authorized under a Safety System Work Permit. There were no injuries or exposures due to this event.

- Work description on the SSWP was incomplete and did not include cable installation in the B-hutch; consequently return to work inspection was not performed.
- Inspection by Lead Beamline Scientist failed to identify missing securing devices.

- Revised the SSWP procedure to include: sign-off by workers and beamline staff, minimize personnel permitted to remove/install configuration management tags, installation of a tell-tale marker when components are removed from approved configuration. **Complete.**
- Revise the Radiation Safety Component Inspection Checklist process to include verification. **In progress.**

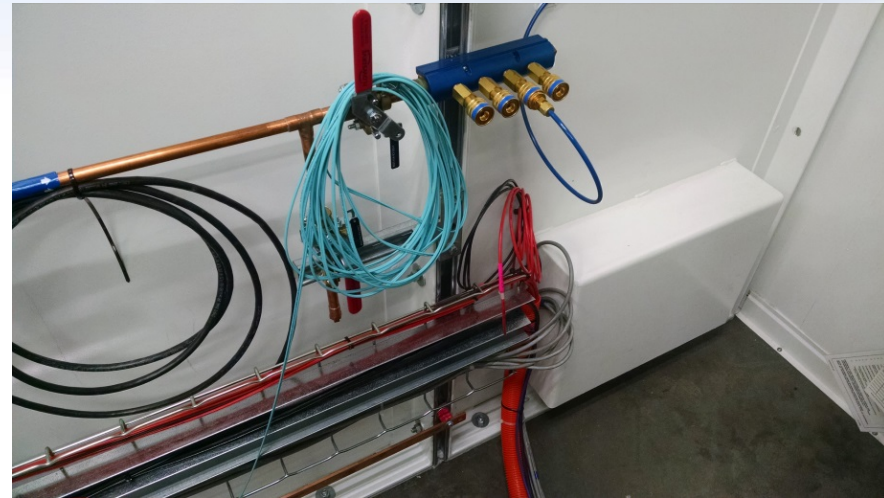
# NSLS-II Uncontrolled Electrical Energy Event

**Description:** An unterminated High Voltage (HV) electrical cable was mistakenly energized resulting in arcing across exposed conductors at the intended instrument end of the circuit. There was no personnel contact and no equipment damage. Review of the power supply specifications and operation indicates no significant shock hazard was present. Although a low-risk event, a mistake in cable management resulted in loss of control of non-hazardous electrical energy.

- Two sets of cables were installed for the same instrument, both were labelled with the same number
- Change control was less than adequate since the installation of the second set of cables was not identified
- Communications between the two work groups (those installing and those terminating the cables) was less than adequate.

- Develop procedures for cable installation, termination, testing and placement into service. **In progress.**
- Complete an Extent of Condition to identify if other cable installation activities will benefit from a common procedure. **In progress.**
- Assure resources are assigned to support cable management improvements. **In progress.**

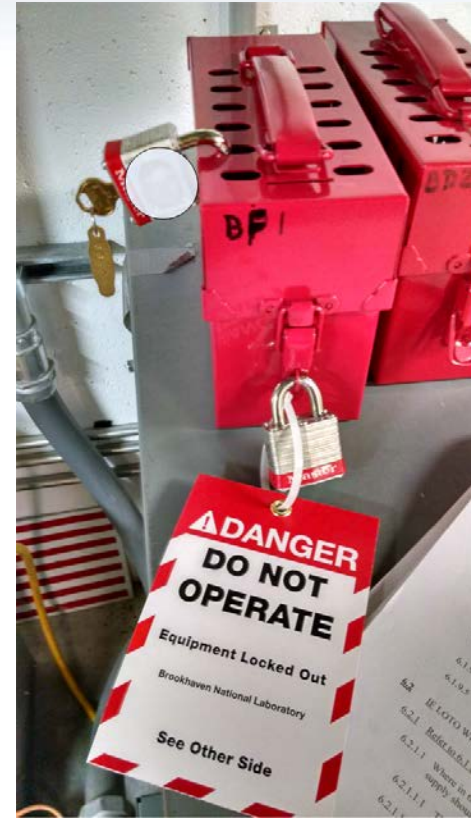
# Failure to Follow Energy Control Process

**Description:** During a DOE inspection of an applied LOTO in the Injection Service Building, a lock was noticed that still had its key engaged. There was no staff in the area so the DOE employee reported the observation to the Electrical Safety Subject Matter Expert. BNL LOTO practices include maintaining ownership of the key at all times when in LOTO. The person responsible for the deviation was questioned. He stated he had been working under LOTO labelling cables and developing a spare parts inventory list. After completing his work and when removing his key he became distracted and failed to take his lock and key with him. There were no injuries or exposures to hazardous energy.

Distraction caused the employee to forget to remove his lock and key when completing work.

- Employee's LOTO qualifications were pulled and the employee required to retake all LOTO training . **Complete.**
- Supervisors to hold tool-box safety talks to discuss the recent NSLS-II events and discuss ways staff can avoid work-place distractions . **In progress.**
