July Roof Repair and Lost X-ray operations

**Diane R. Hatton, Photon Sciences Directorate Chief Operating Officer
for
Erik Johnson, Photon Sciences Directorate Deputy Associate Lab Director
UEC Town Meeting
August 15, 2012**

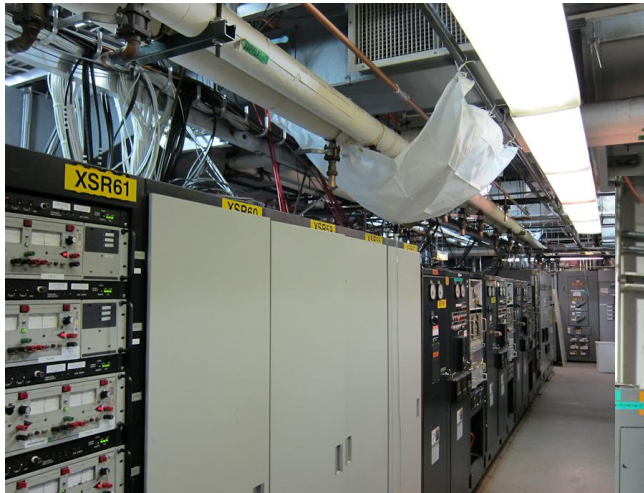
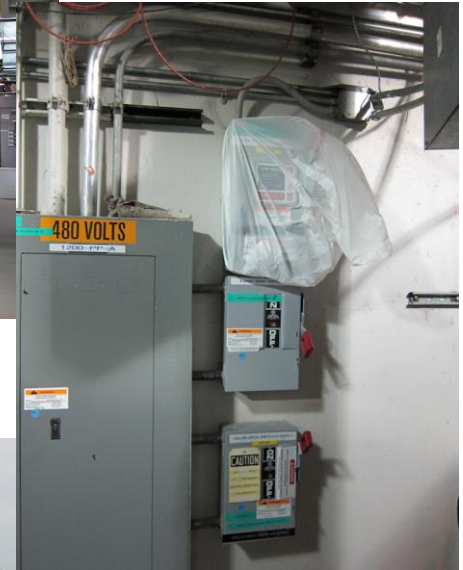
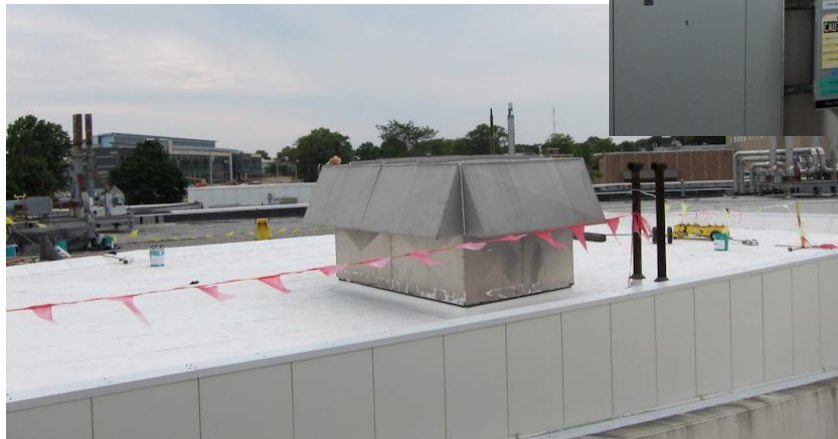
- This portion of the roof is over the X-ray equipment area
- Full of x-ray transmitters, power supplies and lots of 480v equipment
- Water intrusion into the area and onto equipment occurring with alarming frequency
- F&O had resources available to deal with it now

- Work to be completed
 - Replace roof over the RF Electronics Room
 - Removal of existing roof
 - Replacement of Roof material
 - Hot tar application
- Work Permit Meeting – June 22
 - Included walk down of roof area and discussion of proper location of the hot tar kettle. Discussion of keeping hot tar kettle away from HVAC fresh air intake
 - Suggestion that work take place during shutdown period/holiday week -- Week of July 2.
