Machine Update

NSLS Town Meeting

Tuesday July 29, 2014

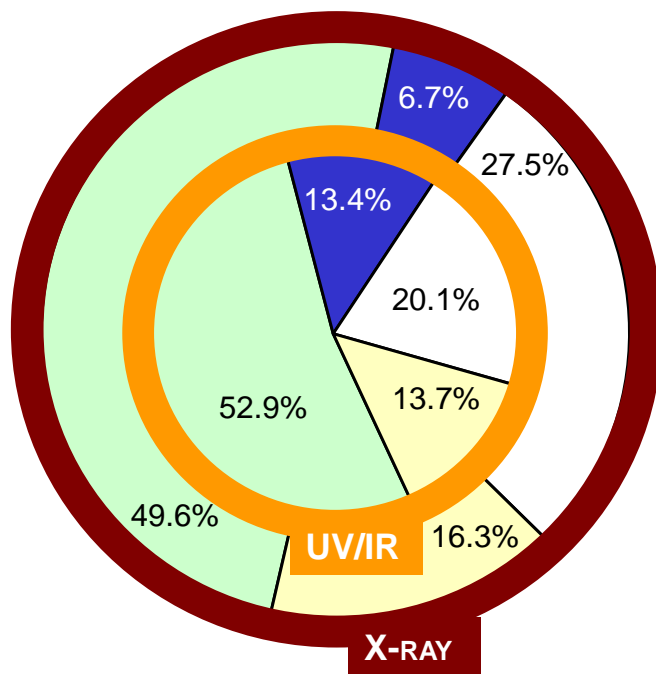
FY 2014 NSLS MACHINE ACTIVITIES

Activity /Hours	UV/IR	X-ray
Operations	3464.7	3248.5
Unscheduled Operations	876.9	436.6
Maintenance	1314.4	1801.0
Other	896.1	1065.9

YTD 6552 Hrs 100 Hrs= 1.5%

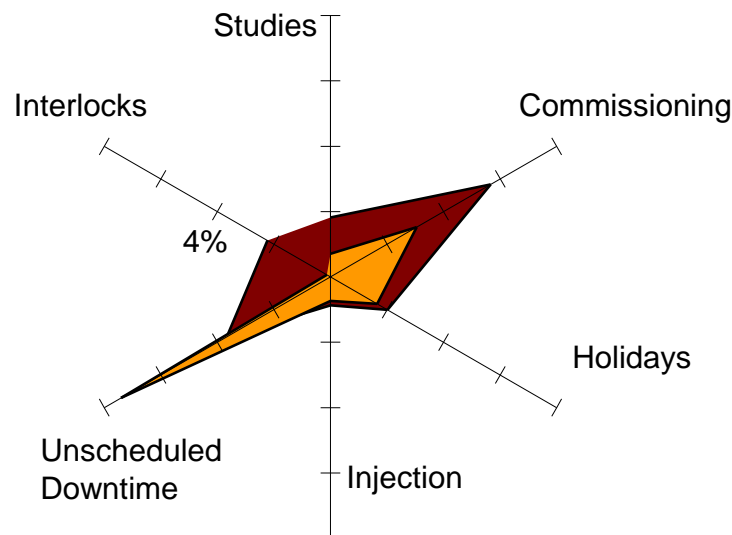
Other Activities	UV/IR	X-ray
Studies	0.7%	1.8%
Com/Con	3.0%	5.7%
Holiday	1.6%	2.0%
Injection	0.7%	0.9%
Unscheduled Downtime	7.4%	3.7%
Interlock	0.1%	2.2%

User Metrics	UV/IR	X-ray
Reliability	87.7%	93.1%
Availability	109.9%	105.6%

Reliability has been dominated by a few events but availability is strong

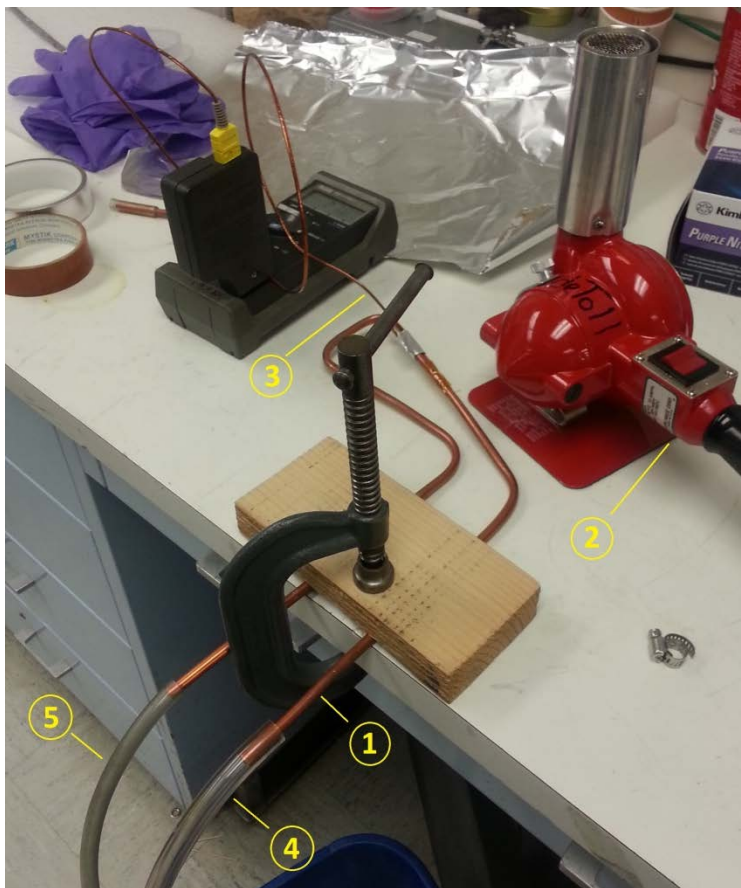
Delivery of the epoxy to the mock up

- Delivery of the Hysol was tested on a mock up by Rob and the vacuum group with very good success
- The Hysol was injected into the cooling line in the ring and dispersed using compressed air left on overnight to ensure no clogs formed
- Ring vacuum began to recover within minutes of the application
- The repair remains intact allowing a return to 300 mA operation with full cooling

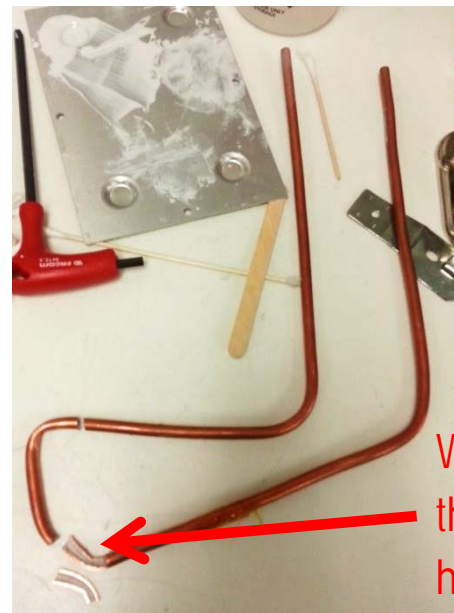
We believe the leak was here

- In May, 1 of 2 cooling lines in the X21 crotch absorber developed a water-to-vacuum leak similar to the X25 leak 1 year before
- Work began to prepare the X25 vacuum chamber for installation in X21 with a new crotch absorber
- The ring ran with 200 mA max for several weeks with 1 cooling channel in operation
- In parallel, from his background in material science, operator Rob Rainer proposed the use of an epoxy to seal the leak in place
- A two part epoxy used in high vacuum applications called Hysol 1C-LV made by Loctite was ordered

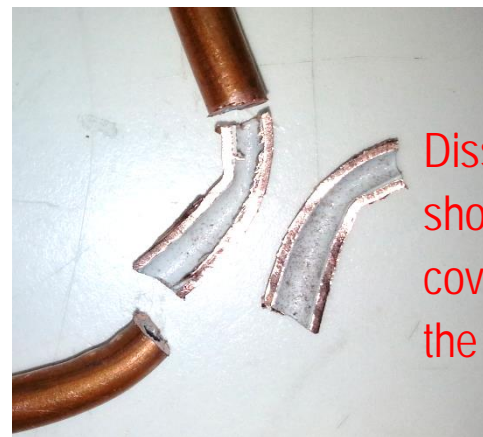
Dissection shows good coverage of the interior

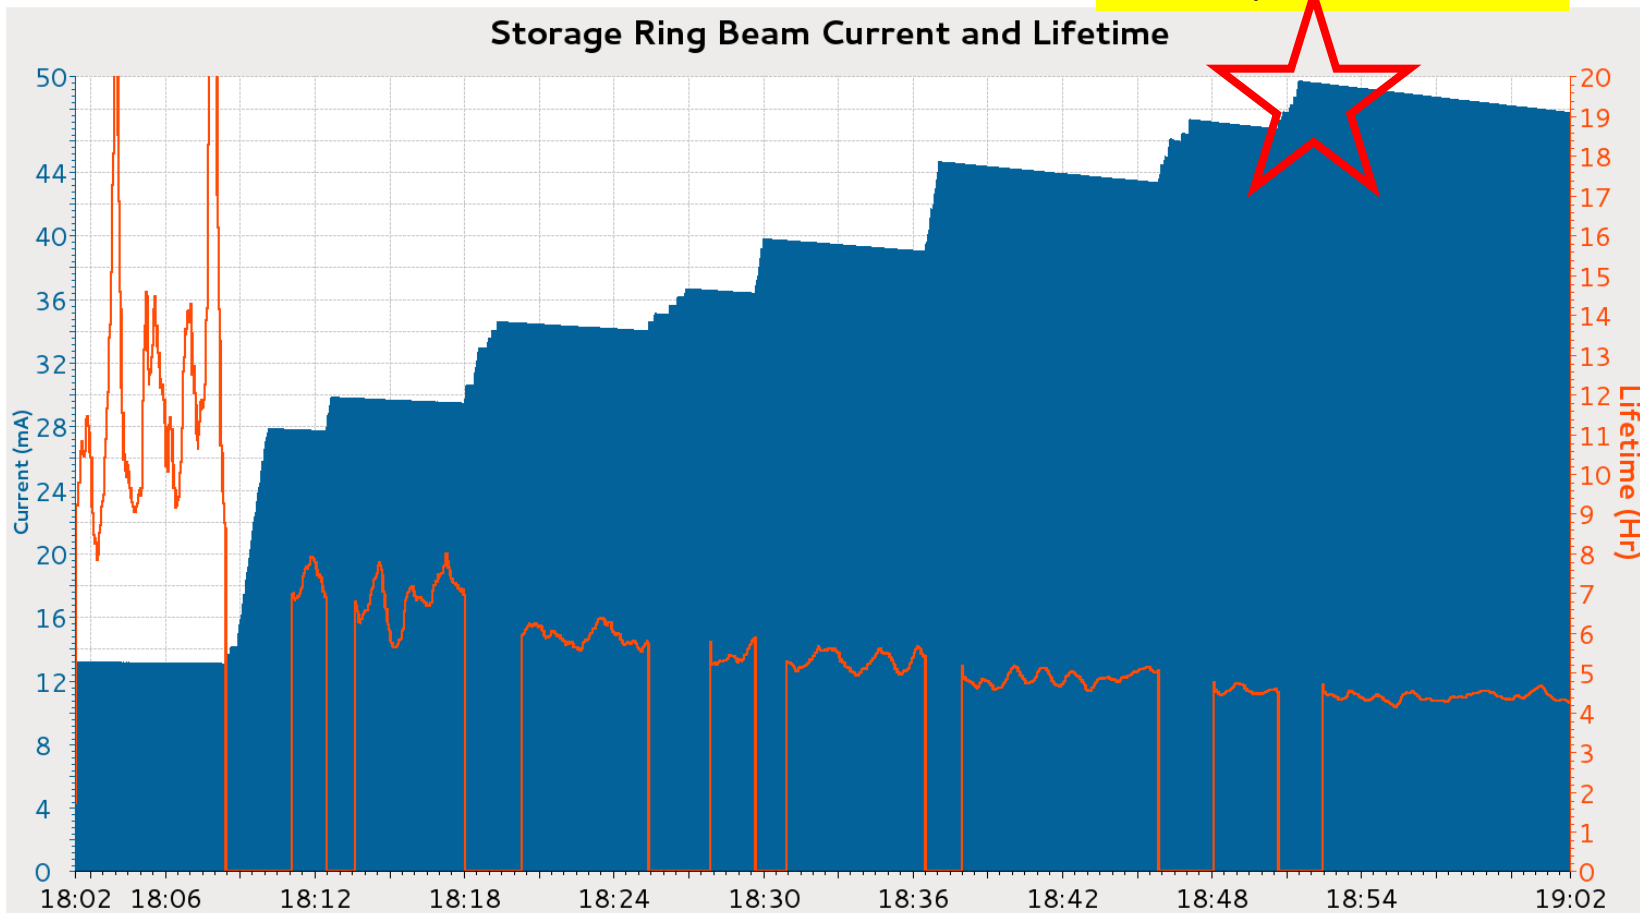
At 6:52 pm we hit 50 mA

- We restarted commissioning and reached 25 mA with the SC cavity early in July and then achieved 50 mA on July 11th before shutting down for the remaining ID and FE component installation
